Technical Appendix 9.3

Peat Slide Risk Assessment

# **Dunbeg South Extension Wind Farm**

FEI Technical Appendix 9.3 Peat Slide Risk Assessment

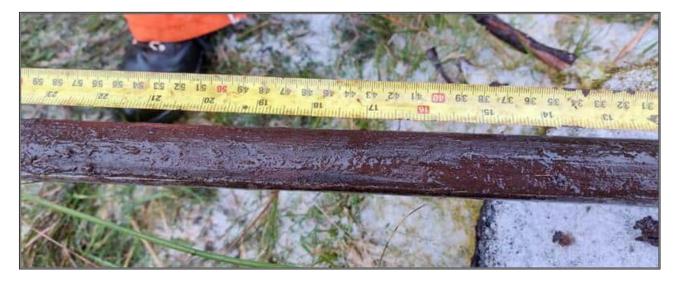
Figure B. 5: Peat core photograph from peat probe position 108 showing firm dark brown plastic pseudo fibrous peat (H7/B2)

Each core is photographed, given a general description, water content estimate (B) and Von Post rating (H) (Table 3.1). Peat deposit characteristics vary across the site. All Peat Cores and photographs are displayed in Figure B.5 of this report. An examples peat core is shown below.

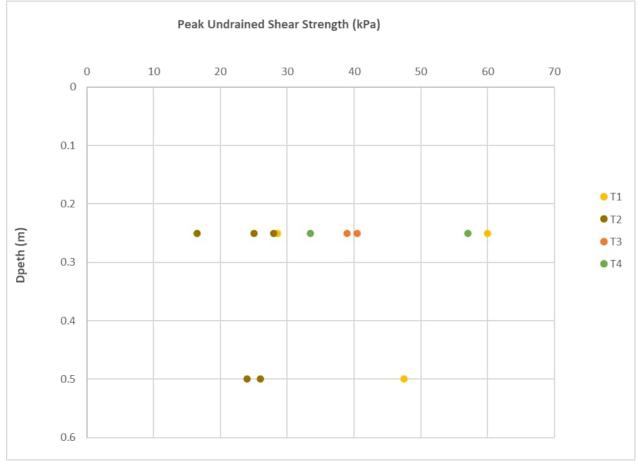
Figure B. 6: Peak undrained shear strength against depth across the site. \*A, denotes previous turbine locations.

The peak undrained shear strength is seen to be variable within the peat deposits with no clear trend against depth. The site wide average is 35kPa (Medium strength) however a conservative value of 17kPa (Very low strength) is considered appropriate for the site wide slope analysis.

Hand shear tests were carried out at core locations where peat depths allowed. Each test was carried out using a Geonor H-60 Hand Shear Vane Tester using a 33mm steel vane. The corrected HSV results are presented within Figure B.6. Locations for each peat core and HSV are presented on Figure A.10 in the appendices.

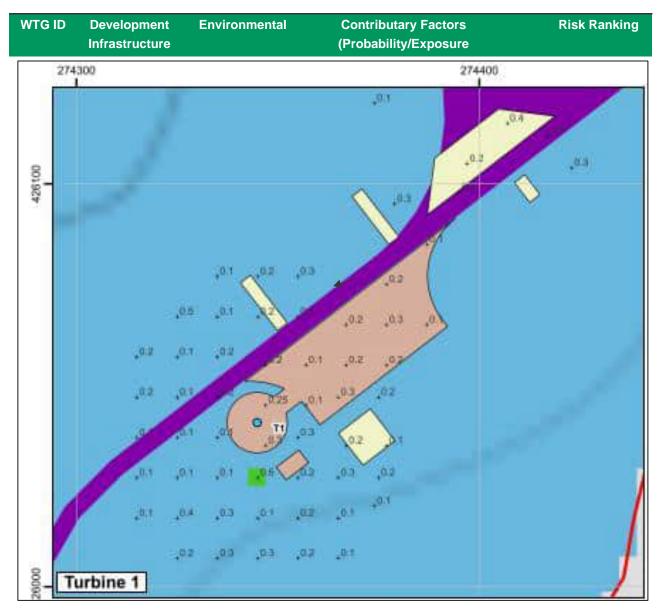
T01 Location – OS Mapping 1:25,000 – 1:5000 Scale Location Specific Mitigation:

None.

Table 6.1: Hazard Ranking Proposed Turbine Location

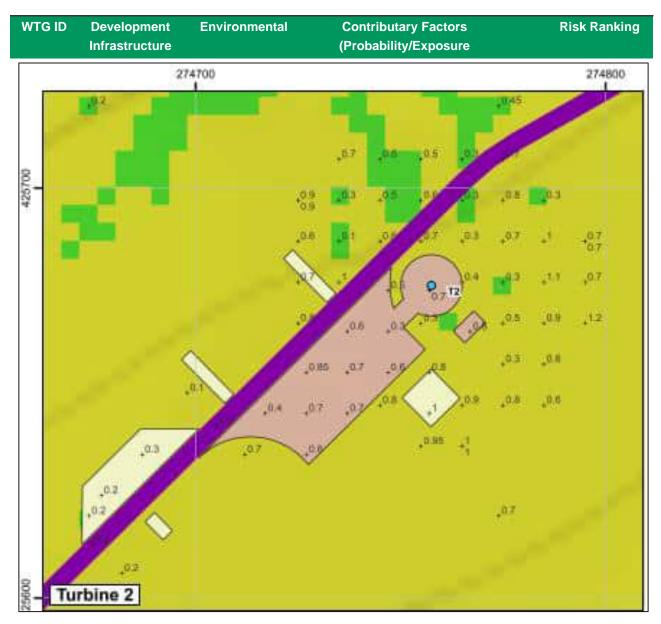
T02 Location - OS Mapping 1:25,000 - 1:5000 Scale

### Location Specific Mitigation:

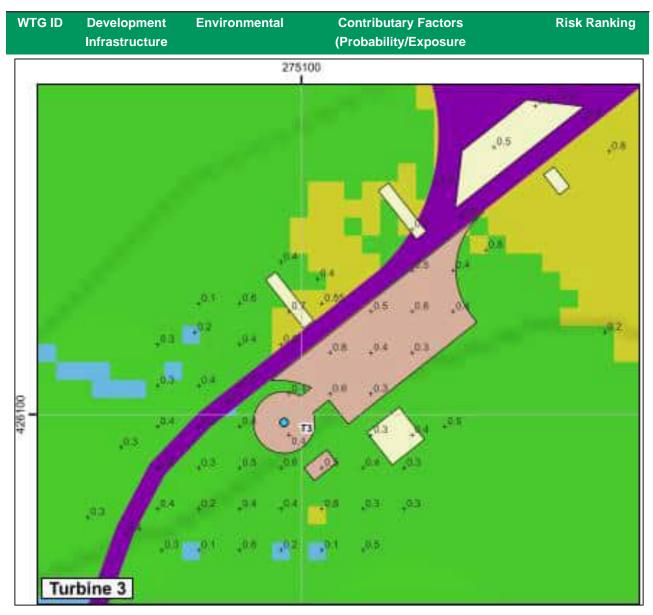
T03 Location – OS Mapping 1:25,000 – 1:5000 Scale Location Specific Mitigation:

None.

Peat Depth (Mean = 0.4m)	1			
			Slope Angle (2°)	1		
			FoS (Min = Cu <sub>min</sub> >	FoS (Min = Cu <sub>min</sub> > site mean)	1	
Т03	1 1		Peat cracking / Infiltration	1	2	
105		· · · · ·	Gro	Groundwater Flow	1	(Negligible)
			Hydrology	1		
			Previous Instability	1		
		Land Management	2

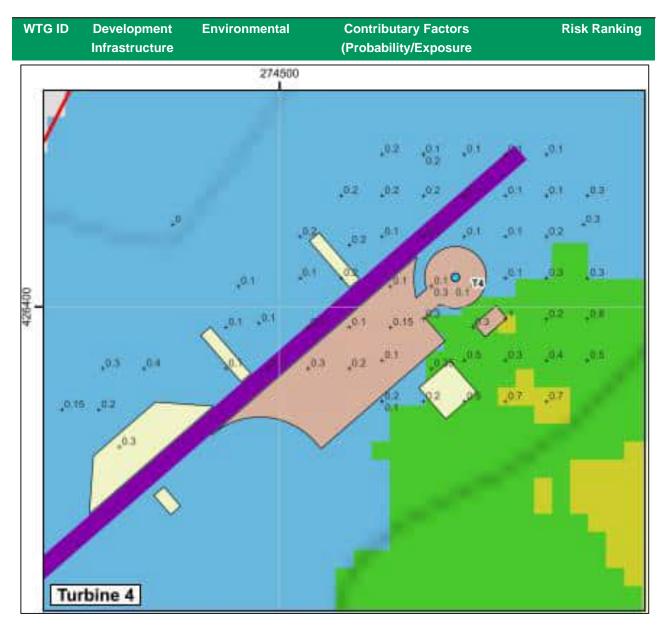
T04 Location - OS Mapping 1:25,000 - 1:5000 Scale

Location Specific Mitigation:

None.

T04	1	1	Peat Depth (Mean = 0.2 m) Slope Angle (2°) FoS (Min = Cu <sub>min</sub> > site mean) Peat cracking / Infiltration Groundwater Flow Hydrology Previous Instability Land Management	1 1 1 1 1 1 1 1 2	2 (Negligible)
-----	---	---	--	---	-------------------

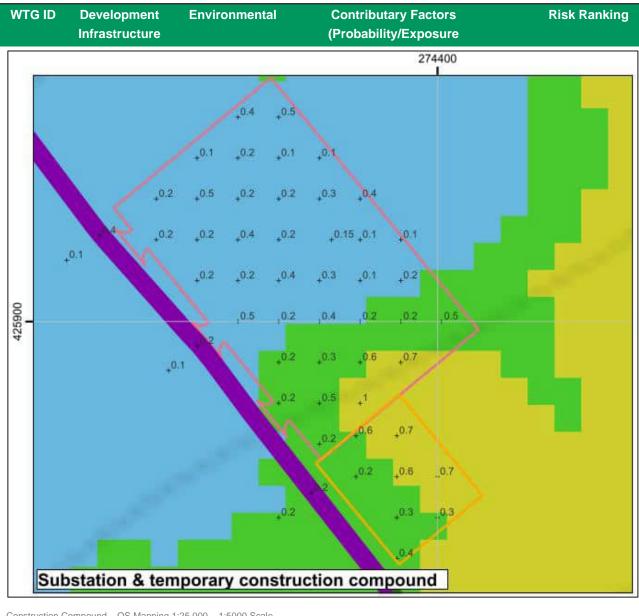
Construction Compound - OS Mapping 1:25,000 - 1:5000 Scale

Location Specific Mitigation:

None.

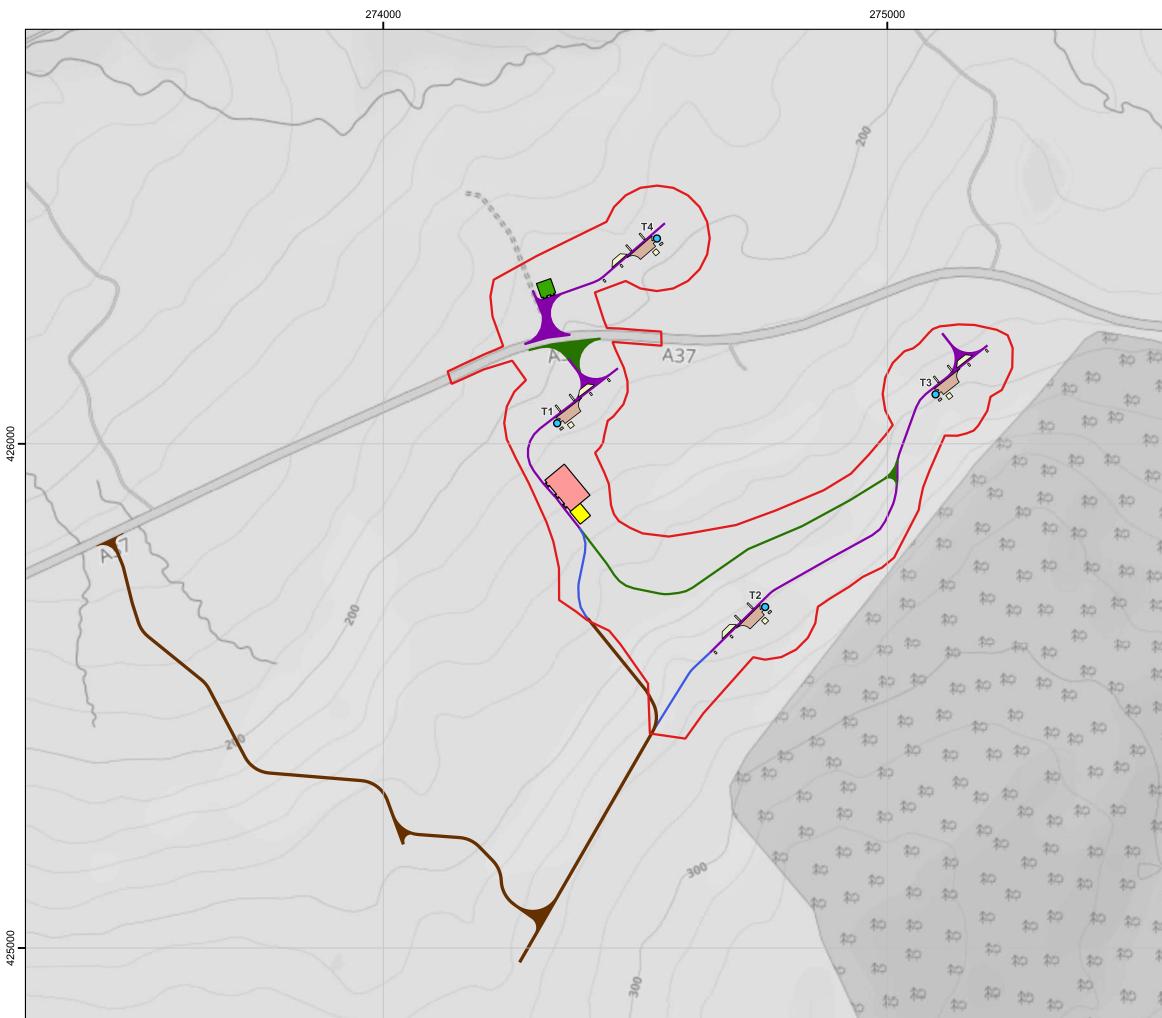
Project: Dunbeg South Extension, Co. Londonderry
_	Title: Site Layout
The second se	Key         Site boundary         Proposed turbine         Proposed permanent hardstanding         Proposed temporary hardstanding         Proposed new track         Proposed new track (Option 1)         Proposed new track (Option 2)         Existing access via Dunbeg South wind farm         Temporary construction compound         Small construction compound         Proposed substation
341	© Thunderforest, © OpenStreetMap contributors.  Scale @ A3:1:7,500 Coordinate System: TM65 Irish National Grid  0 100 200 300 400 m

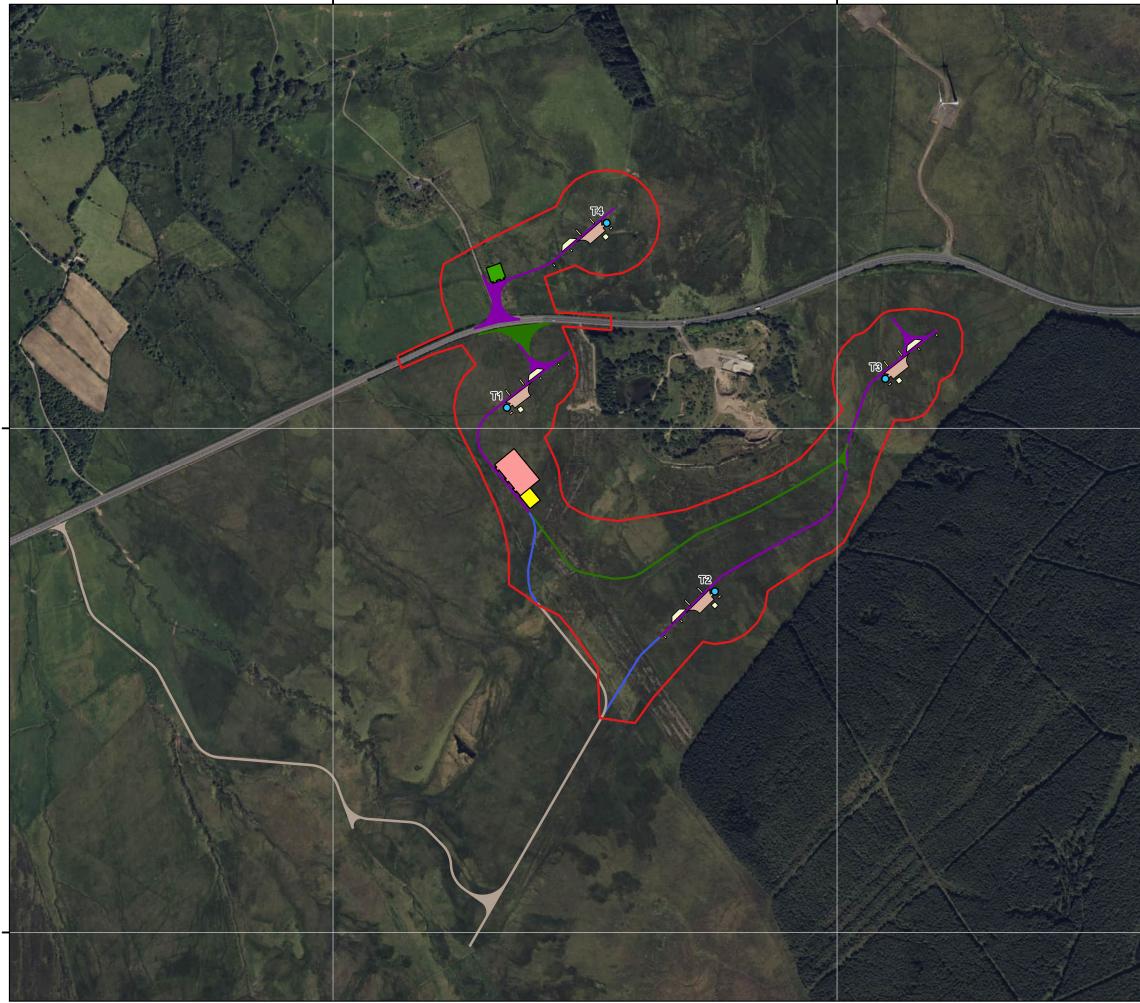
Project: Dunbeg South Extension, Co. Londonderry
Title: Aerial Imagery & Site Layout
<ul> <li>Key</li> <li>Site boundary</li> <li>Proposed turbine</li> <li>Proposed permanent hardstanding</li> <li>Proposed temporary hardstanding</li> <li>Proposed new track</li> <li>Proposed new track (Option 1)</li> <li>Proposed new track (Option 2)</li> <li>Existing access via Dunbeg South wind farm</li> <li>Temporary construction compound</li> <li>Small construction compound</li> <li>Control building</li> </ul>
Microsoft product screen shot reprinted with permission from Microsoft Corporation $\ensuremath{\mathbb{G}}$ Bing.
Scale @ A3:1:7,500 Coordinate System: TM65 Irish National Grid
0 100 200 300 400 m
Date: 19-07-24 Prepared by: DH Checked by: EE
Ref: IE200135_M_019_A         Layout: 030524_4t_A

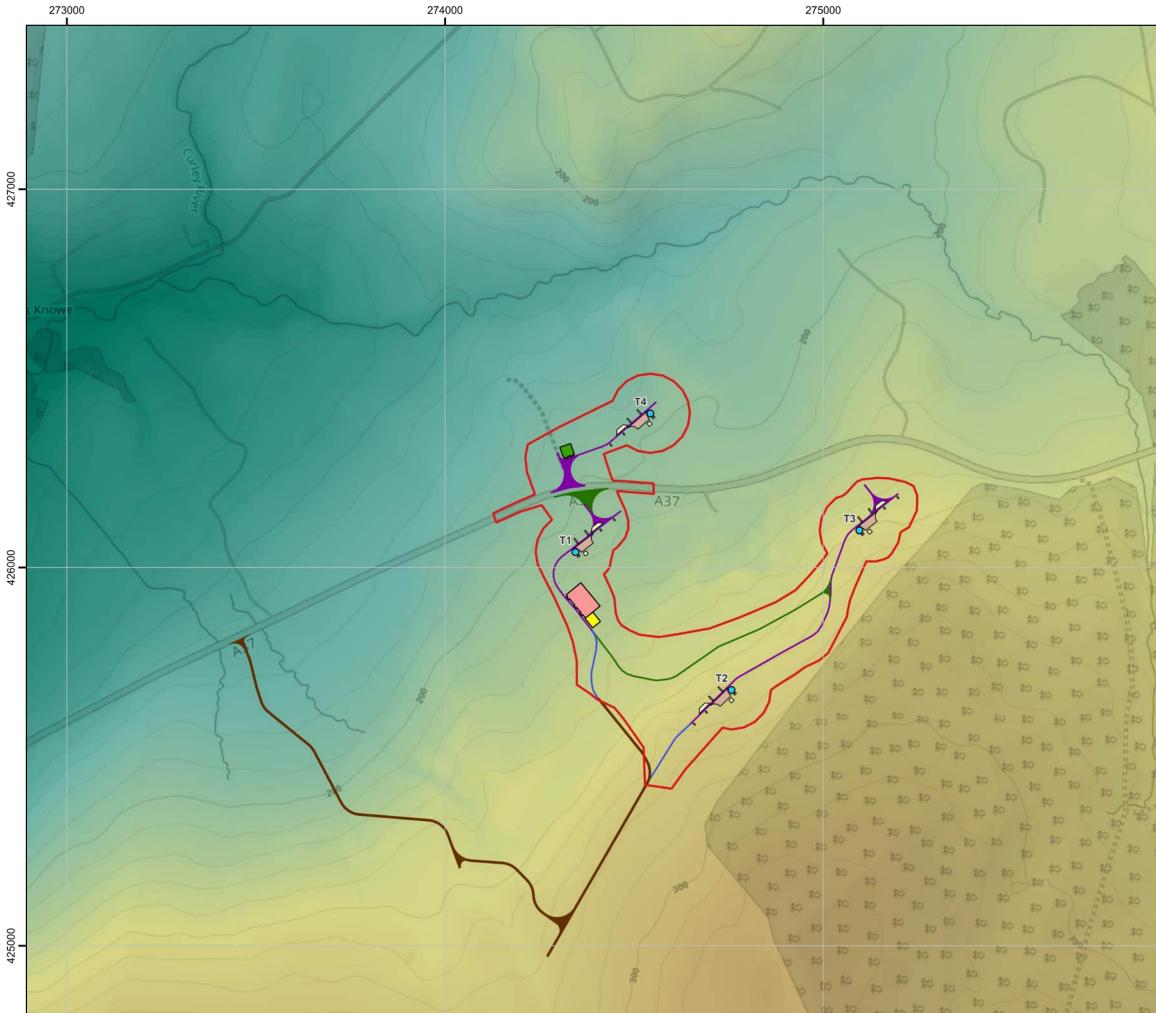
Project: Dunbeg South Extension, Co. Londonderry
Title: Site Topography
Key         Site boundary         Proposed turbine         Proposed permanent hardstanding         Proposed temporary hardstanding         Proposed new track         Proposed new track (Option 1)         Proposed new track (Option 2)         Existing access via Dunbeg South wind farm         Temporary construction compound         Small construction compound         Control building         Height above MSL (m)         100
© Thunderforest, © OpenStreetMap contributors. © Crown copyright. Ordnance Survey of Northern Ireland.
Scale @ A3:1:10,000           Coordinate System: TM65 Irish National Grid         N           0         100         200         300         400 m           L         L         L         L         L         L
Date: 19-07-24 Prepared by: DH Checked by: EE
Ref: IE200135_M_018_A Layout: 030524_4t_A

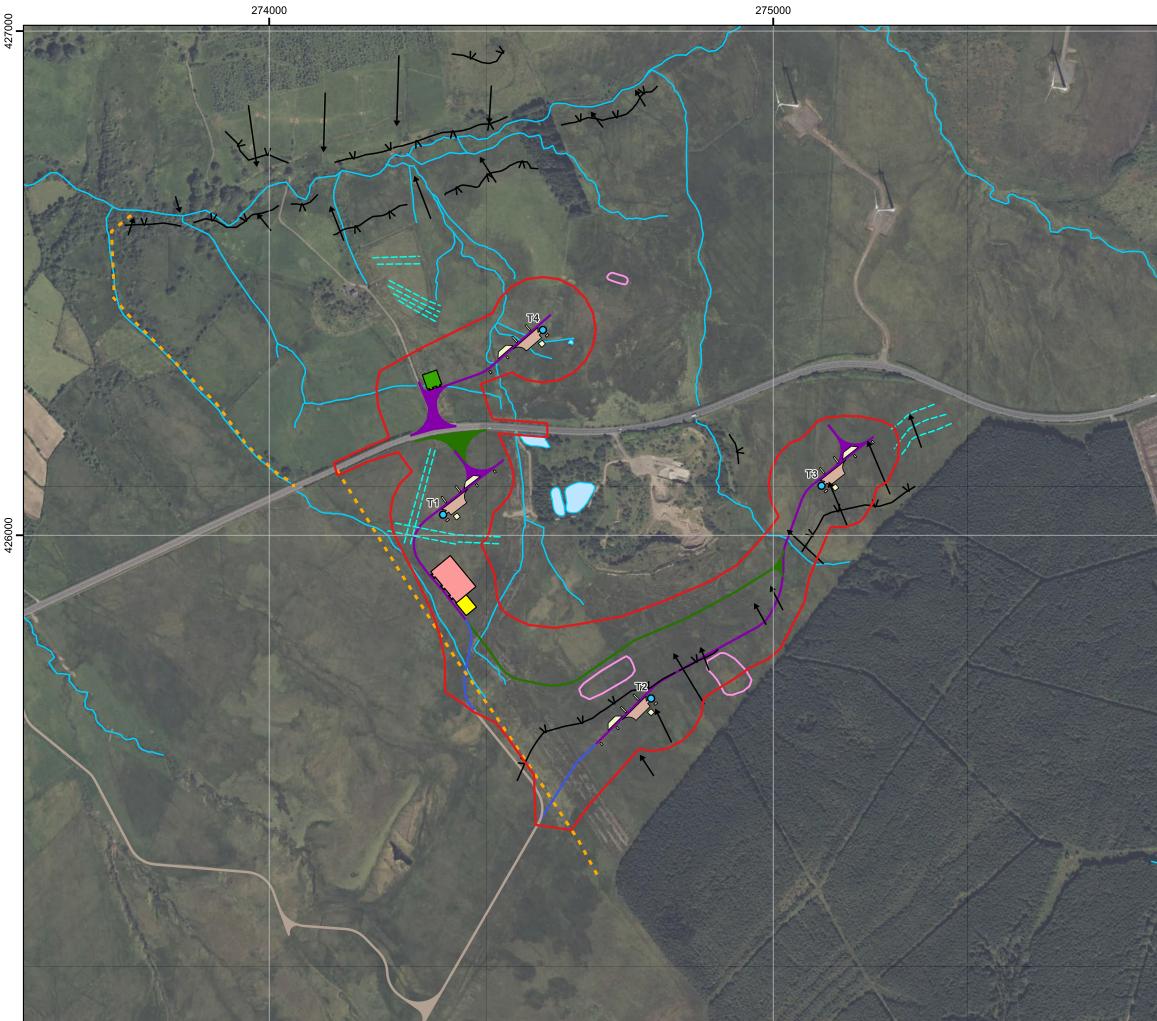
Project: Dunbeg South Extension, Co. Londonderry
Title: Geomorphological Features
Key         Site boundary         Proposed turbine         Proposed permanent hardstanding         Proposed temporary hardstanding         Proposed new track         Proposed new track (Option 1)         Proposed new track (Option 2)         Existing access via Dunbeg South wind farm         Temporary construction compound         Small construction compound         Control building         Beamorphological Features         Historic area of peat cutting         Natural watercourse         Water body         Relic drainage feature         Footpath         Slope direction
Microsoft product screen shot reprinted with permission from Microsoft Corporation © Bing.
Scale @ A3:1:7,500 Coordinate System: TM65 Irish National Grid N
0 100 200 300 400 m
Date: 19-07-24 Prepared by: DH Checked by: EE
Ref: IE200135_M_022_A Layout: 030524_4t_A

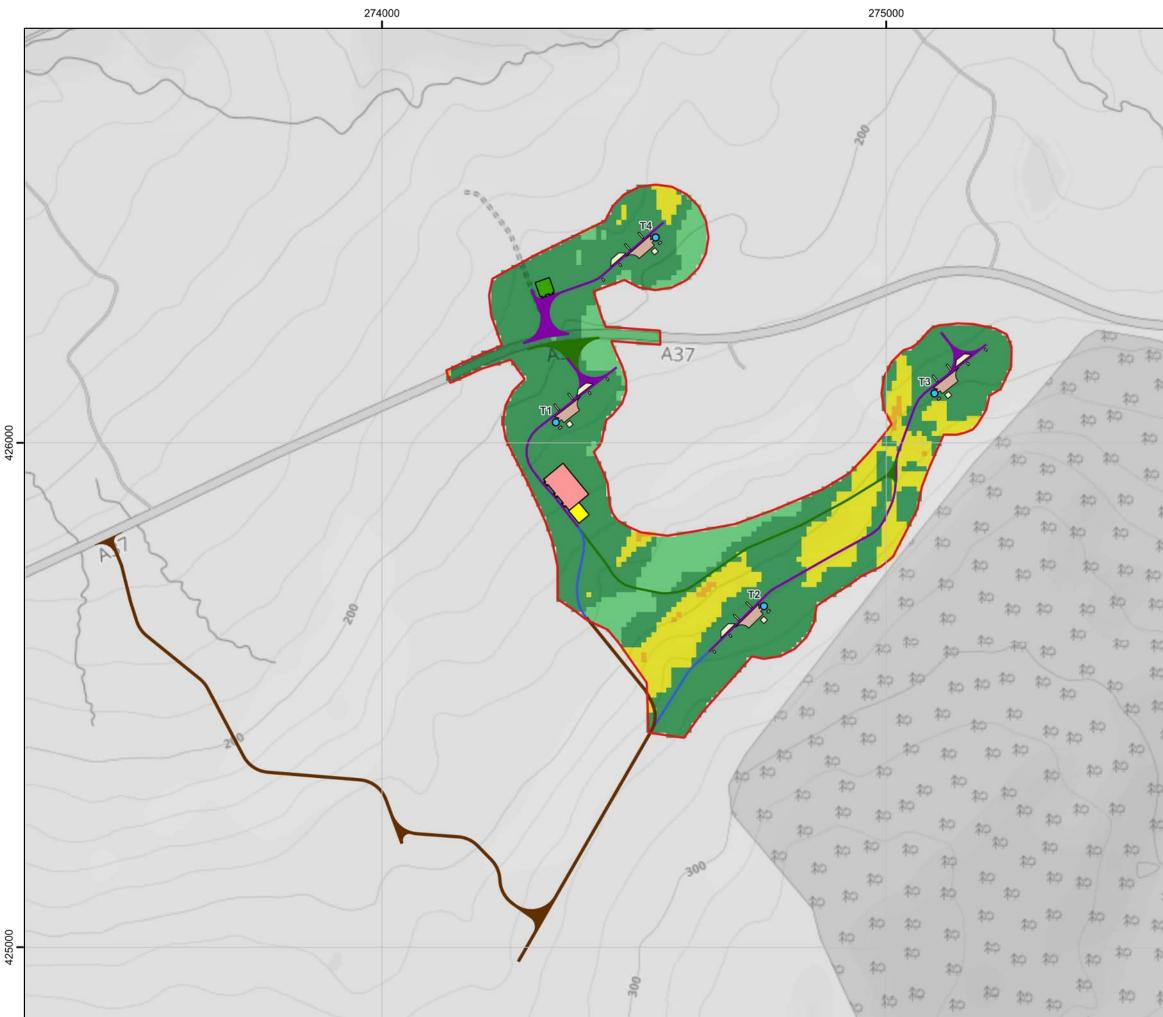
Project: Dunbeg South Extension, Co. Londonderry
1	Title: Slope Angle
	KeySite boundaryProposed turbineProposed permanent hardstandingProposed temporary hardstandingProposed new trackProposed new track (Option 1)Proposed new track (Option 2)Existing access via Dunbeg South wind farmTemporary construction compoundSmall construction compoundProposed substationSlope angle (degrees) * $0^\circ - \le 3^\circ$ $3^\circ - \le 9^\circ$ $9^\circ - \le 15^\circ$ $15^\circ - \le 20^\circ$ * Slope calculated using OSNI 10 m DTM.

There are several steeper areas found on the site, reaching up to 21° such as in the southwest and southeast of the site where the terrain slopes down to the north (274556E, 425887N and 275022E, 426054N respectively). There is also moderately steep terrain up to 20° on the sides of the Curley River tributary that flows east to west along the northern part of the site (e.g. at 274394E, 426813N). These areas of steeper terrain were found to have almost entirely peat depths less than 0.50m during the stage 1 probing survey and satellite imagery shows no signs of slope instability.

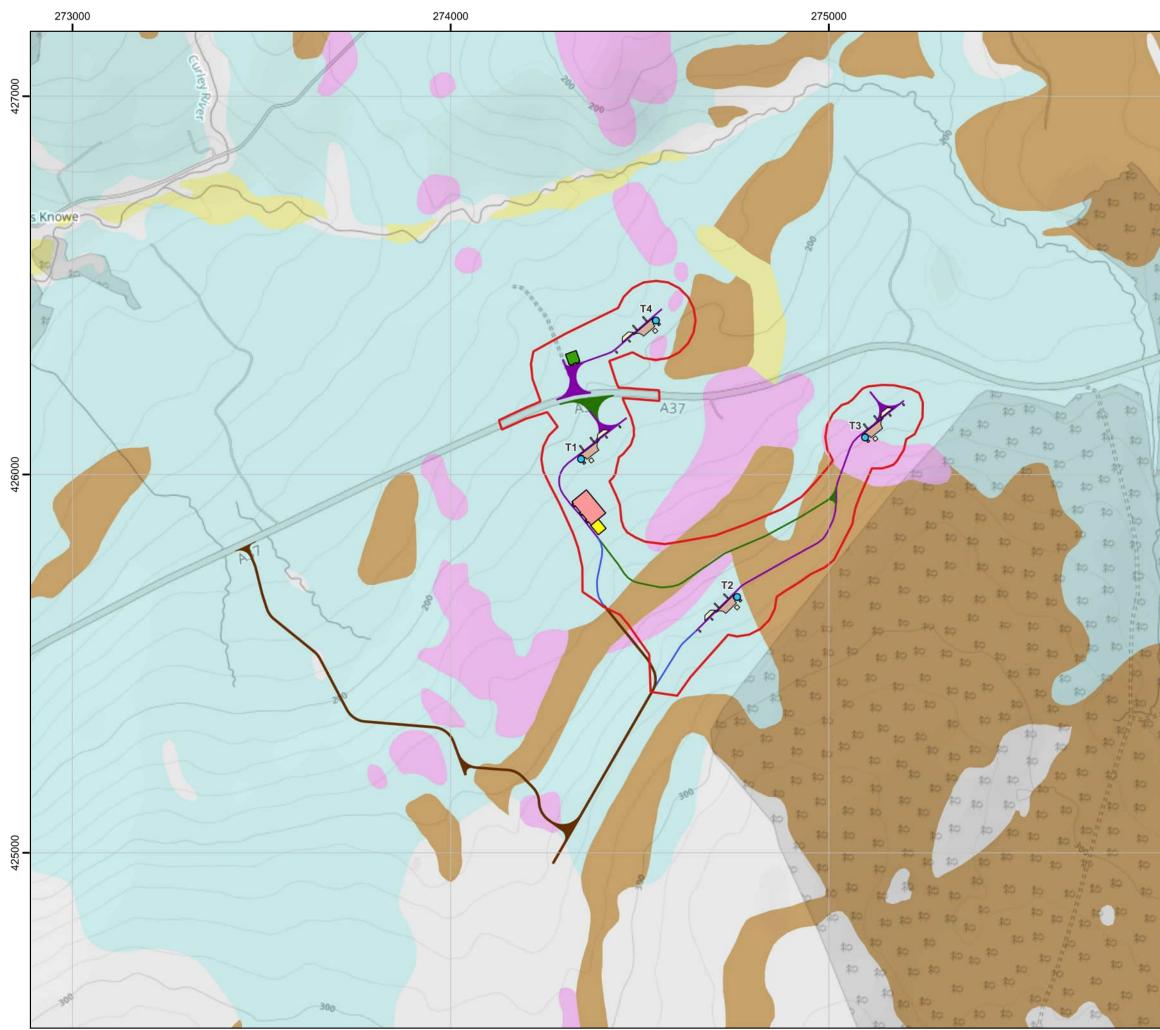
Project: Dunbeg South Extension, Co. Londonderry
Title: Superficial Geology
<ul> <li>Key</li> <li>Site boundary</li> <li>Proposed turbine</li> <li>Proposed permanent hardstanding</li> <li>Proposed temporary hardstanding</li> <li>Proposed new track</li> <li>Proposed new track (Option 1)</li> <li>Proposed new track (Option 2)</li> <li>Existing access via Dunbeg South wind farm</li> <li>Temporary construction compound</li> <li>Small construction compound</li> <li>Control building</li> <li>Superficial Deposits</li> <li>Alluvium - Silt, Sand and Gravel</li> <li>Glaciofluvial Deposits - Gravel, Sand and Silt</li> <li>Till, Devensian - Diamicton</li> <li>Peat</li> </ul>
Geological Survey of Northern Ireland © Crown Copyright 2024. © Thunderforest, © OpenStreetMap contributors.
Scale @ A3:1:10,000           Coordinate System: TM65 Irish National Grid         N           0         100         200         300         400 m

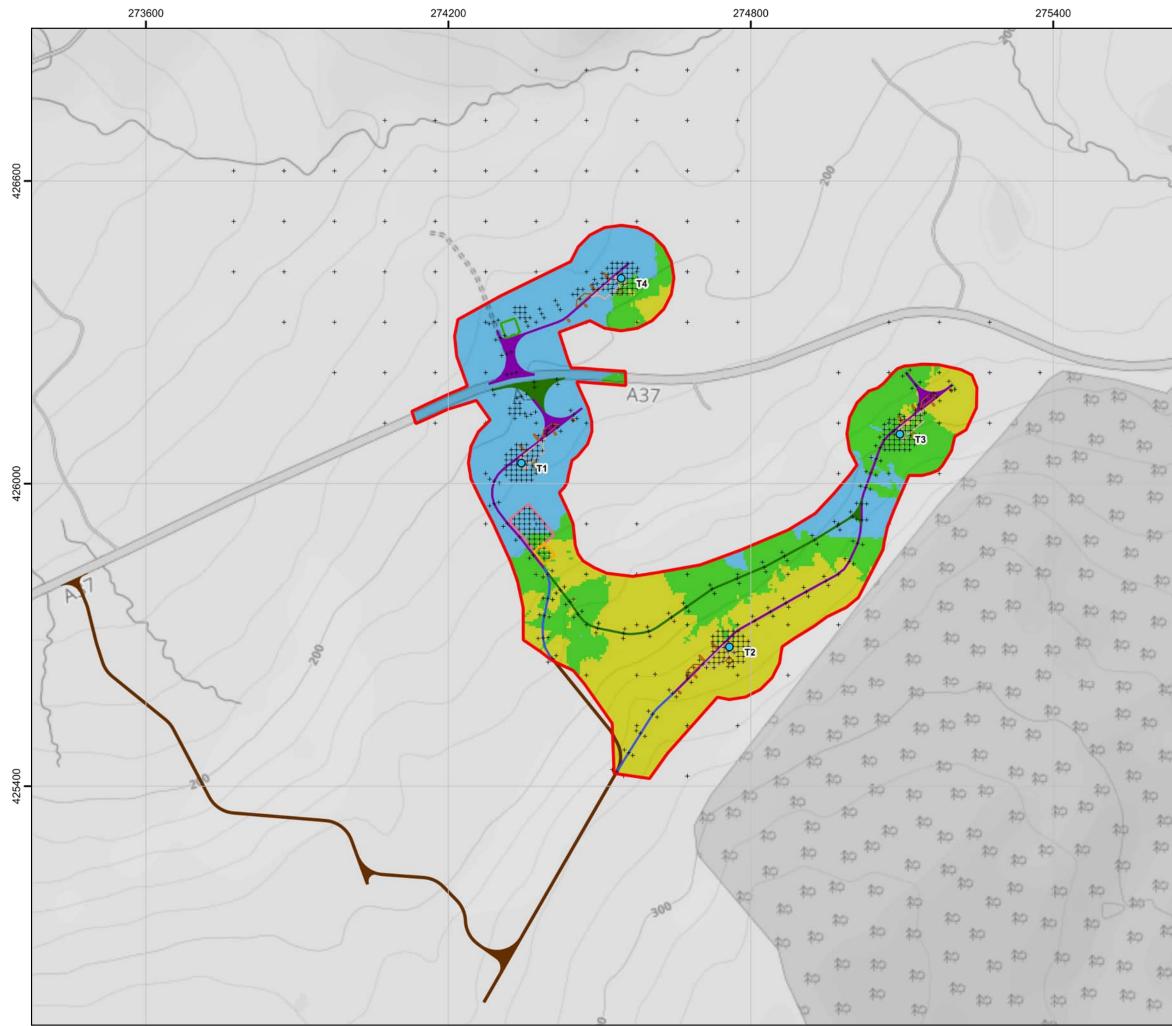
Project: Dunbeg South Extension, Co. Londonderry
1.1	Title: Interpolated Peat Depth (Page 1 of 3)
	Key         Site boundary         Proposed turbine         Proposed permanent hardstanding         Proposed temporary hardstanding         Proposed new track         Proposed new track (Option 1)         Proposed new track (Option 2)         Existing access via Dunbeg South wind farm         Proposed substation         Proposed substation         Proposed small construction compound         + Peat probe         Interpolated peat depth (m) *         <= 0.3         0.3 - 0.5         0.5 - 1         1 - 2         2 - 3         > 3         * Peat depth interpolated using the Kriging method
10	© Thunderforest, © OpenStreetMap contributors.
	Scale @ A3: 1:7,500           Coordinate System: TM65 Irish National Grid         N           0         100         200         300         400 m
	Date: 19-07-24 Prepared by: DH Checked by: EE

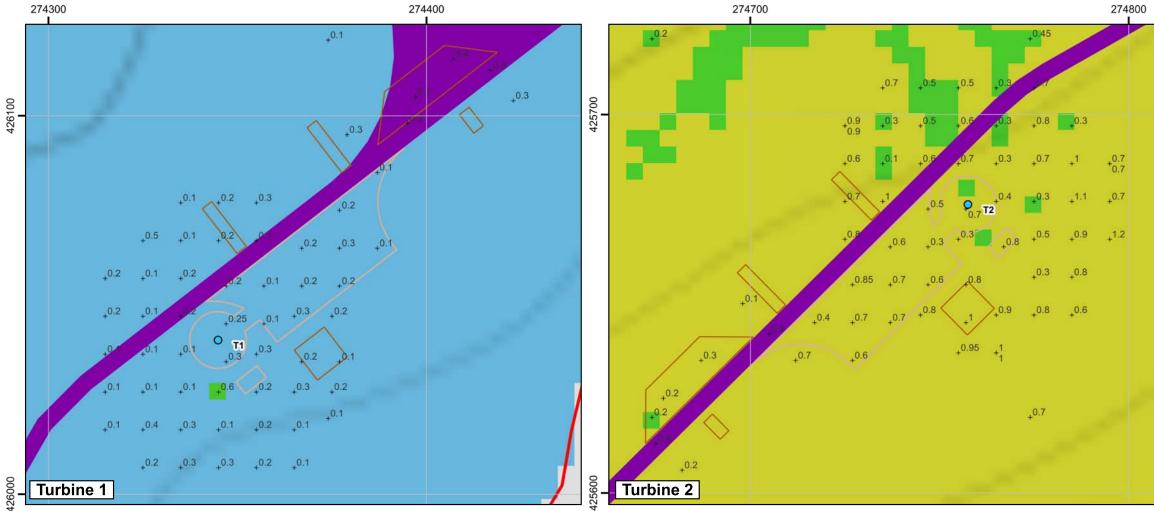
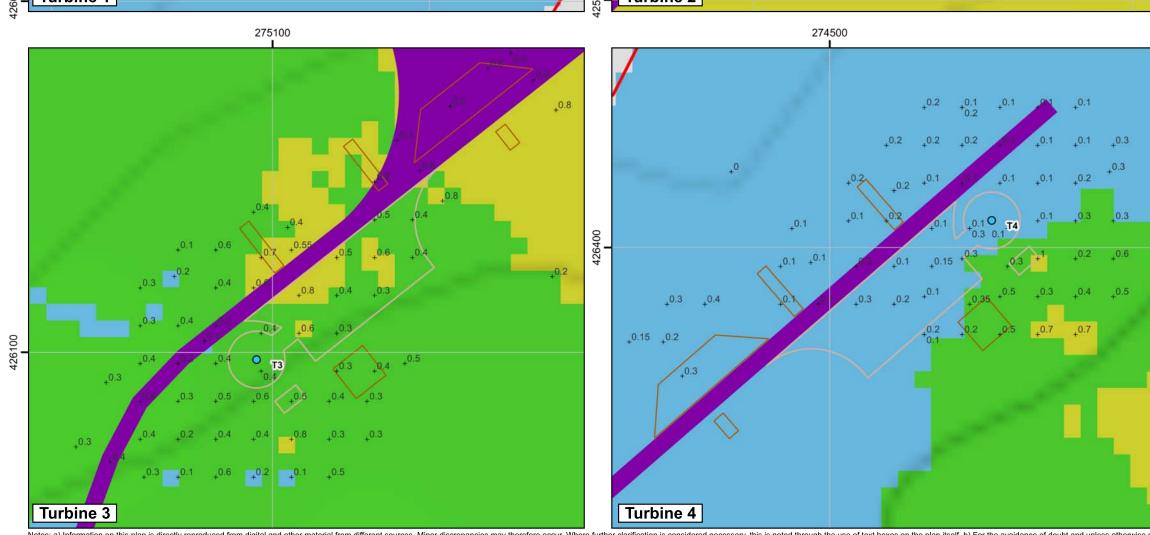
Project: Dunbeg South Extension, Co. Londonderry
Title: Interpolated Peat Depth (Page 2 of 3)
Кеу
Proposed turbine
Proposed permanent hardstanding
Proposed temporary hardstanding
Proposed new track
+ Peat probe
Interpolated peat depth (m) *
<= 0.3
0.3 - 0.5
0.5 - 1
1 - 2
2 - 3
> 3
* Peat depth interpolated using the Kriging method
© Thunderforest, © OpenStreetMap contributors. Scale @ A3: 1:1,000 Coordinate System: TM65 Irish National Grid
0 10 20 30 40 m
Date: 19-07-24 Prepared by: DH Checked by: EE
Ref: IE200135_M_011_C Layout: 030524_4t_A
Drawing by: The Natural Power Consultants Limited The Green House Forrest Estate, Dalry Castle Douglas, DG7 3XS, UK Tel: +44 (0)1644 430008 Fax: +44 (0)845 299 1236 Email: sayhello@naturalpower.com www.naturalpower.com

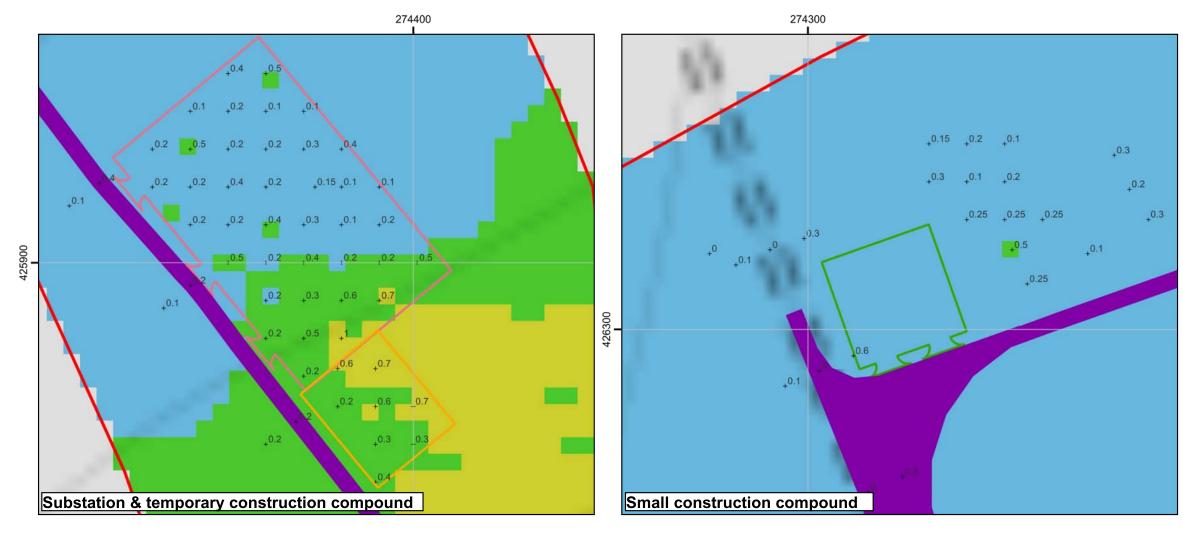
Project: Dunbeg South Extension, Co. Londonderry
Title: Interpolated Peat Depth (Page 3 of 3)
Key         Proposed new track         Proposed substation         Proposed temporary construction compound         Proposed small construction compound         +       Peat probe         Interpolated peat depth (m) *         <= 0.3         0.3 - 0.5         0.5 - 1         1 - 2         2 - 3         > 3    * Peat depth interpolated using the Kriging method
© Thunderforest, © OpenStreetMap contributors.
Coordinate System: TM65 Irish National Grid     N       0     10     20     30     40 m
Date: 19-07-24 Prepared by: DH Checked by: EE
Ref: IE200135_M_011_C Layout: 030524_4t_A
Drawing by: The Natural Power Consultants Limited The Green House Forrest Estate, Dalry Castle Douglas, DG7 3XS, UK Tel: +44 (0)1644 430008 Fax: +44 (0)845 299 1236 Email: sayhello@naturalpower.com www.naturalpower.com

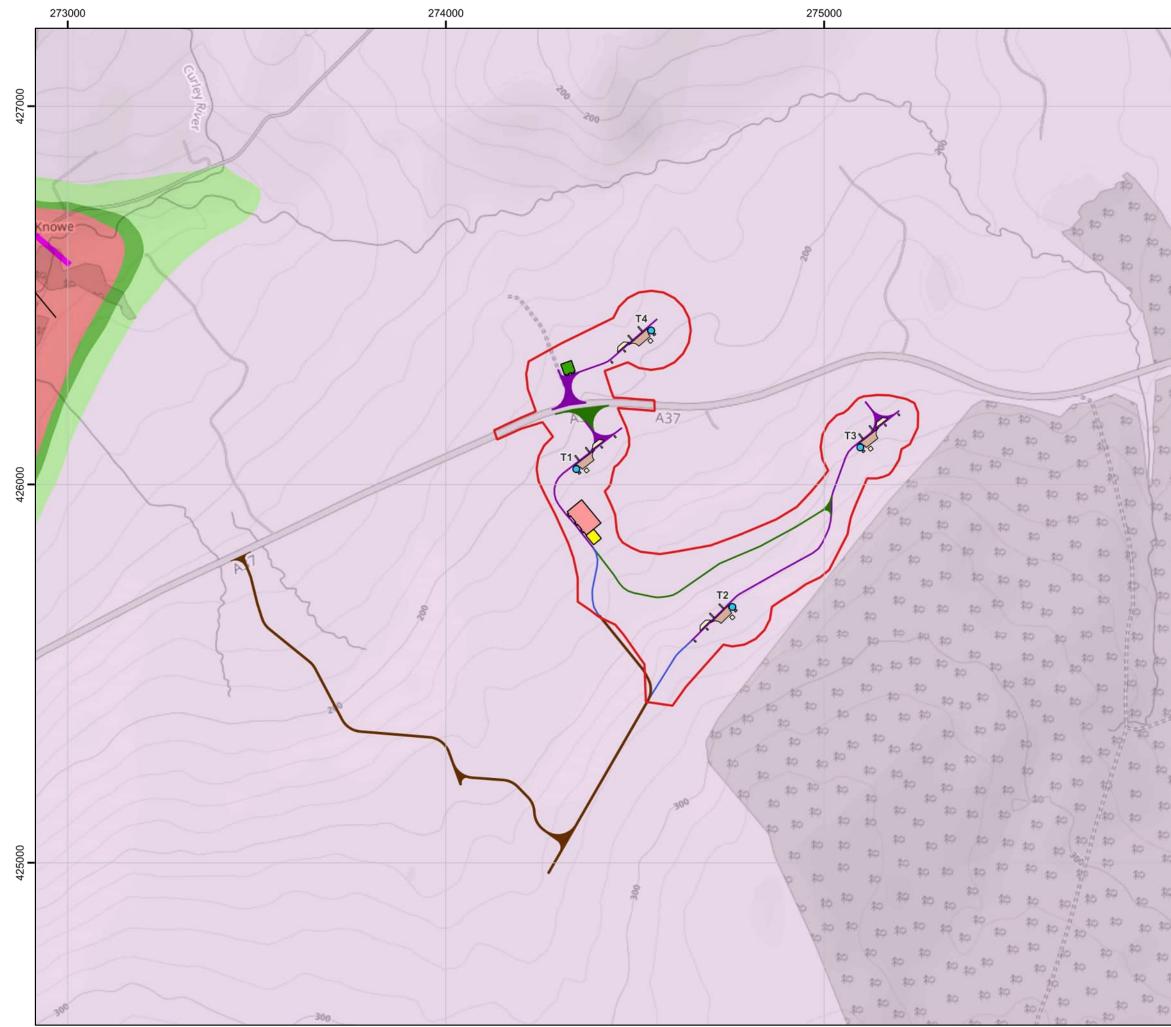
Project: Dunbeg South Extension, Co. Londonderry
	Title: Bedrock Geology
	Key         Site boundary         Proposed turbine         Proposed permanent hardstanding         Proposed temporary hardstanding         Proposed new track         Proposed new track (Option 1)         Proposed new track (Option 2)         Existing access via Dunbeg South wind farm         Temporary construction compound         Small construction compound
	Control building Bedrock Geology Upper Basalt Formation - Basalt Ulster White Limestone - Chalk Hibernian Greensands Group - Sandstone, glauconitic Mercia Mudstone Group - Mudstone Unnamed Dyke, Palaeogene - Microgabbro Fault, observed
	Geological Survey of Northern Ireland © Crown Copyright 2024. © Thunderforest, © OpenStreetMap contributors.
	Scale @ A3: 1:10,000           Coordinate System: TM65 Irish National Grid         N           0         100         200         300         400 m           L         L         L         L         L         L

The site is underlain by the basalt bedrock, classed by the GSNI as a locally important aquifer. Hydraulic conductivity varies from low to moderate; some primary conductivity in the weathered horizons, but principally secondary development of joints and other fissures. Sustainable borehole yields range from only 0.5l/s to 20l/s, a yield between 5 and 10l/s is however typical.

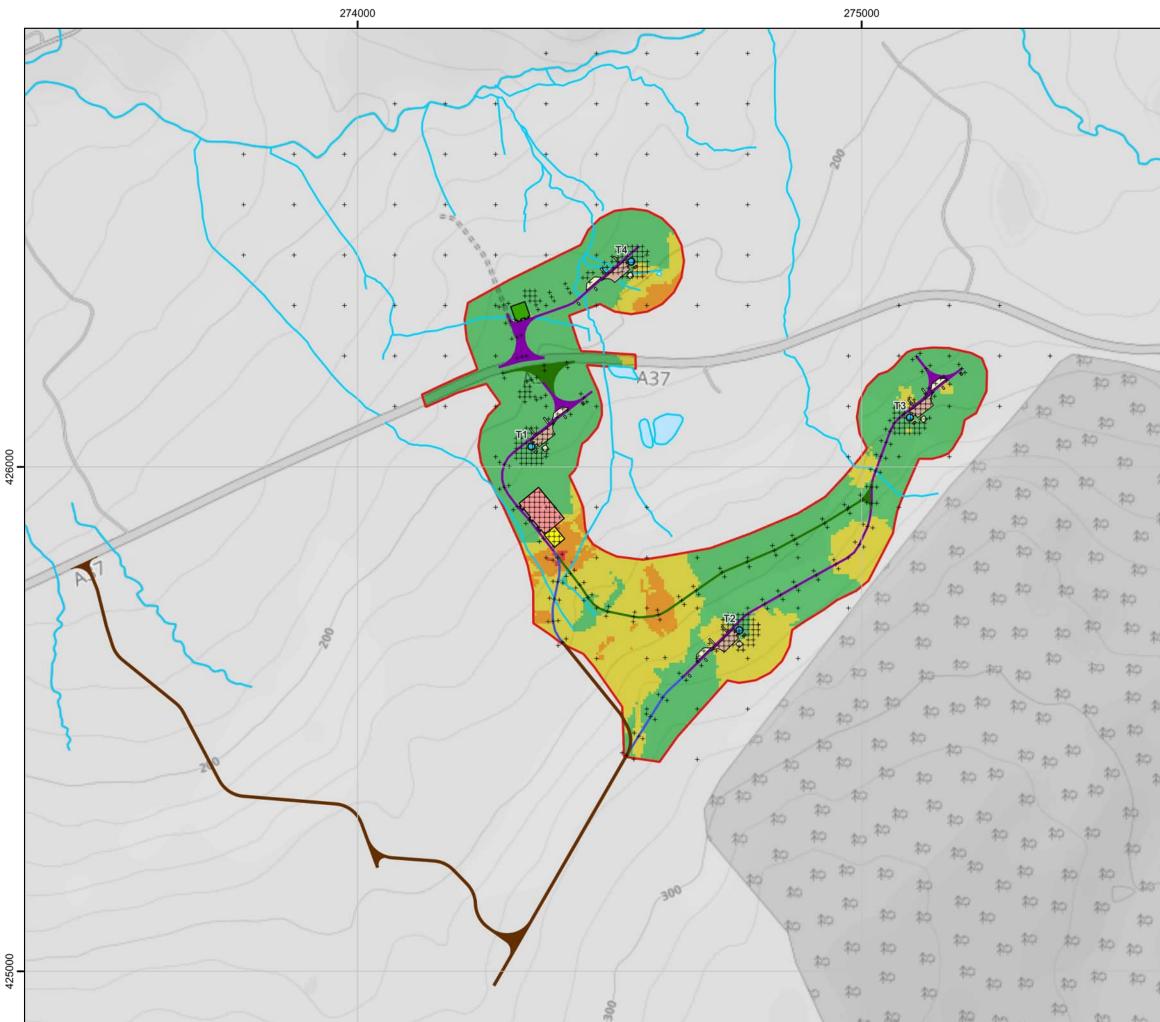
Project: Dunbeg South Extension, Co. Londonderry
	Title: Peat Stability Risk Ranking
	Key         Site boundary         Proposed turbine         Proposed permanent hardstanding         Proposed temporary hardstanding         Proposed new track         Proposed new track (Option 1)         Proposed new track (Option 2)
N D DE	<ul> <li>Existing access via Dunbeg South wind farm</li> <li>Temporary construction compound</li> <li>Small construction compound</li> <li>Proposed substation</li> <li>Watercourse</li> <li>Water body</li> <li>+ Peat probe</li> </ul>
100 100 M	Peat Stability Risk Ranking (PSRR) * 1 ≤ 4 Negligible** 5 ≤ 10 Low 11 ≤ 16 Medium > 16 High * Peat Slide Risk Zones = (Peat depth + Slope) x Proximity
不 不	<ul> <li>to watercourse</li> <li>** Exception: where peat depth is 0.5m or below, PSRR is deemed negligible, regardless of other factors.</li> <li>© Thunderforest, © OpenStreetMap contributors.</li> </ul>

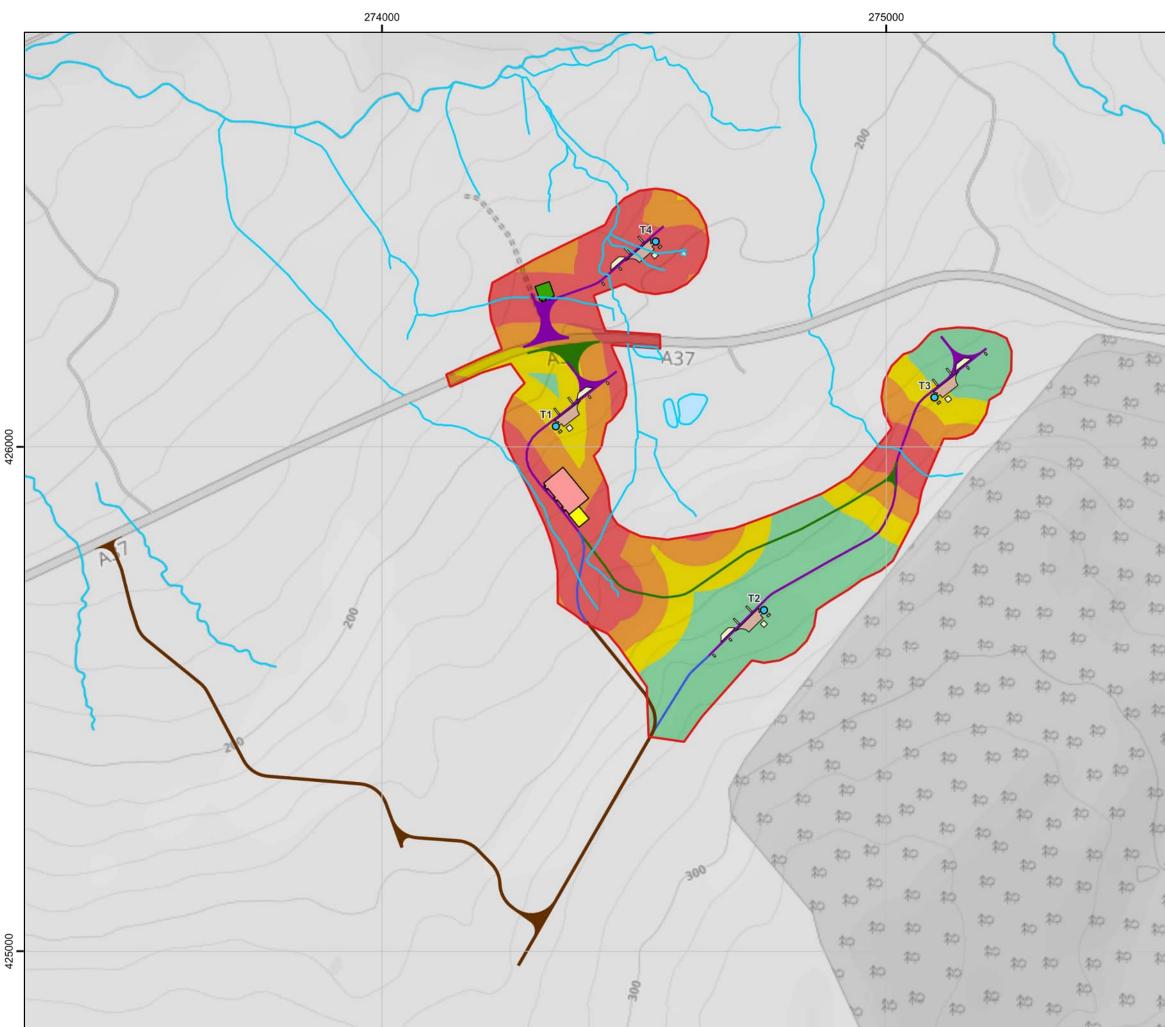
Project: Dunbeg South Extension, Co. Londonderry					
Title: Environmental Impact Zones						
	Key         Site boundary         Proposed turbine         Proposed permanent hardstanding         Proposed temporary hardstanding         Proposed new track         Proposed new track (Option 1)         Proposed new track (Option 2)         Existing access via Dunbeg South wind farm         Temporary construction compound         Small construction compound         Proposed substation         Watercourse         Water body         Environmental Impact Zones         High (< 50 m from watercourse/water body)         Low (100 - 150 m from watercourse/water body)         Low (100 - 150 m from watercourse/water body)         Negligible (> 150 m from watercourse/water body)
